## Identifying aging and installation issues in an HV bushing

## CASE STUDY

## Identifying aging and installation issues in an HV bushing – Analysis with 1 and 500 Hz PF

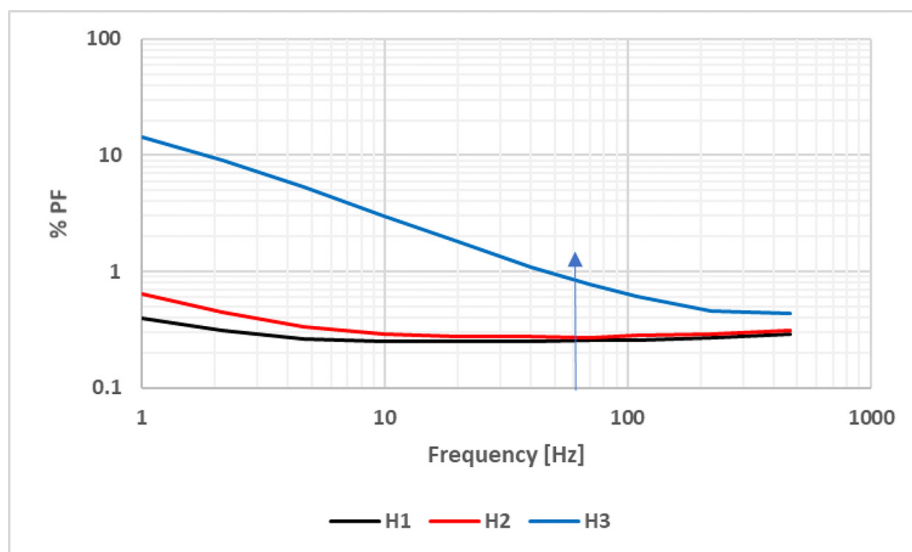
Figure 1: NB DFR measured test results for the high-side 69 kV bushings

- Given the LF PF test results, the utility performed NB DFR tests on the high-side bushings. 1 Hz and 505 Hz measurements from this testing are provided in Table 2. These tabular results affirm the good condition and rating of bushings H1 and H2 but escalate the assessment of the H3 bushing to an investigate rating.

NB DFR test results for bushing H3 (the blue trace in Figure 1) revealed the following two worrisome electrical characteristics and the utility replaced the bushing.

- A bushing in good condition will have an ITC temperature-corrected PF value  $\leq 1\%$  at 1 Hz. The ITC temperature-corrected 1 Hz PF test result of bushing H3 was 7.92 % (Table 2).
- The 10 kV LF PF test result, 1.1 % (Table 2), and the LF PF test result at 250 V, a typical NB DFR test voltage, taken from Figure 1, 0.8 %, are different. This implies a voltage dependence of the LF PF test results.

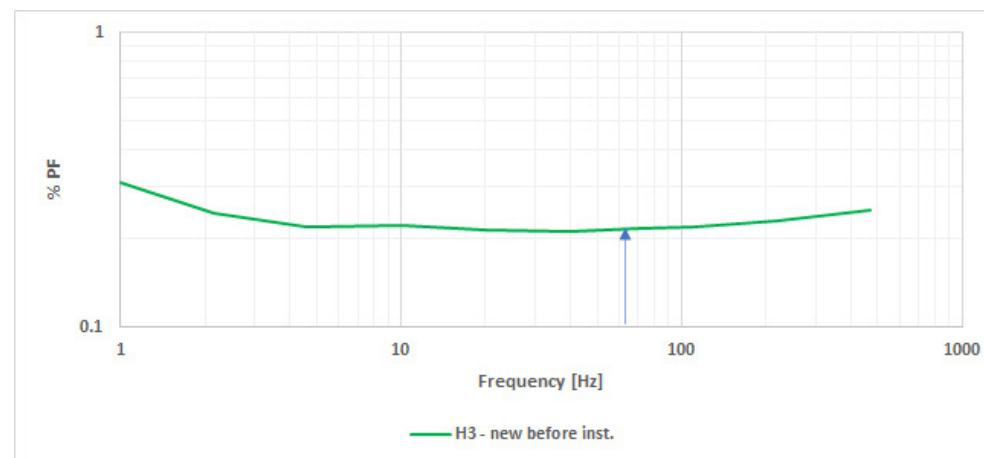
Figure 2: Pre-installation NB DFR test results for H3 replacement bushing

- Before installing in the transformer, LF PF and NB DFR testing was performed on the H3 replacement bushing to confirm its integrity. LF PF and NB DFR test results indicated the bushing's good (G) condition (Table 3) (Figure 2).

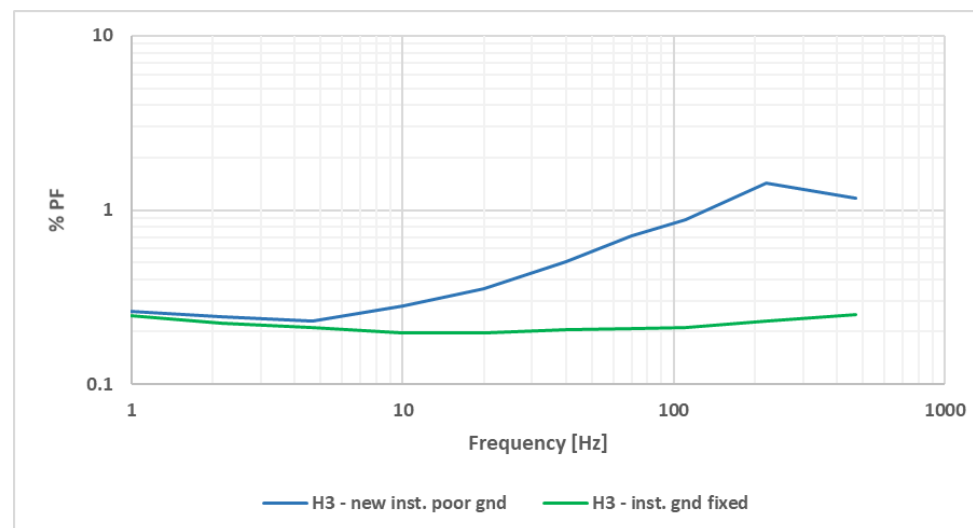
Figure 3: Ground effect on the NB DFR test results of H3 replacement bushing

- The 10 kV measured LF PF test result for the H3 replacement bushing was acceptable. However, the ITC temperature-corrected LF PF result is ~ 1.5 times the measured value while the 1 Hz measured and ITC temperature-corrected results are nearly the same and the 505 Hz PF test result is both non-typical and notably higher than the 505 Hz PF test results for the H1 and H2 bushings.
- NB DFR tests for the installed H3 replacement bushing revealed a non-typical response, with uncharacteristically high losses in the high frequency range (blue curve in Figure 3).

- The data implicated the connection integrity of the bushing flange to the grounded tank. To verify the suspected grounding problem, the testing specialist applied a ground strap to the bushing flange and repeated the LF PF and NB DFR tests (Table 6). A significant improvement was observed in the LF PF test results and the dielectric response with the ground strap in use (green curve in Figure 3).

- It should be noted that the field test specialist had no prior experience with detecting poor flange grounding. When presented with the probable cause of this 505 Hz anomaly, the specialist used a multimeter and measured the resistance between the tank ground and bushing flange with no notice of a resistance issue. Only with the use of a four-terminal low resistance test instrument was the specialist able to detect a 'before and after' difference. This underscores the exceptional sensitivity of a NB DFR test to insufficient bushing grounding.

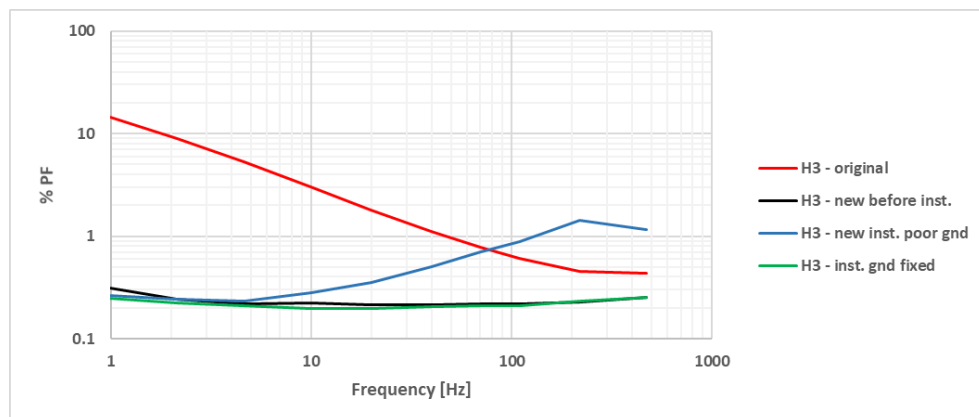
Figure 5: H3 bushing NB DFR test curves from 'as found' to 'as left'

- The NB DFR curves of the original H3 bushing, the H3 replacement bushing before installation, after installation with poor grounding, and finally in its 'as left' condition after restoring a good ground connection are shown in Figure 5. This provides a striking visual reminder of how bad the original bushing was, how practical NB DFR is for post-installation verification, and what the DFR curve for a bushing in good condition should look like.
