# Reducing failure risk of HV instrument transformers in the transmission system

**CASE STUDY**  
NB DFR on HV CVTs

## – application of narrowband dielectric frequency response (NB DFR) on HV CVTs

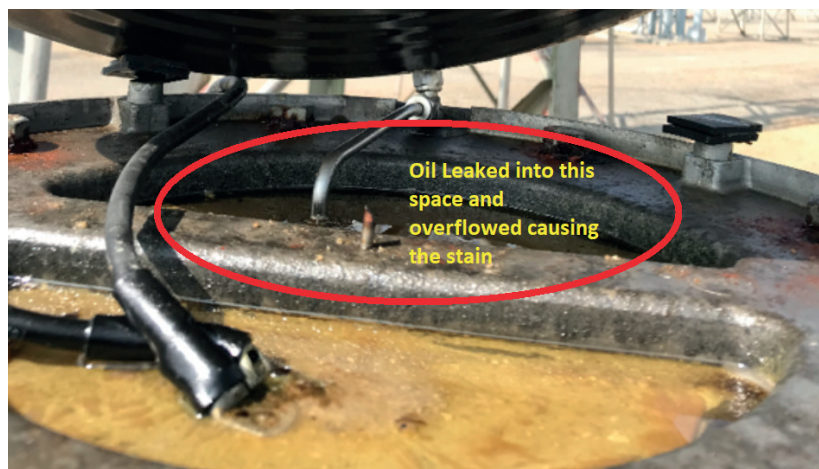
Figure 11: Oil overflow due to puncture on top of C1-B1 section

■ An ensuing teardown of CVT-2 confirmed significant damage to its C1 – B1 section (Figure 11.). Specifically:

- A puncture was found in the C1-B1 section
- Oil was missing from the top portion of C1-B1 section.
- Its insulation integrity was compromised
- Ratio was not affected
- CVT-2 was also replaced.

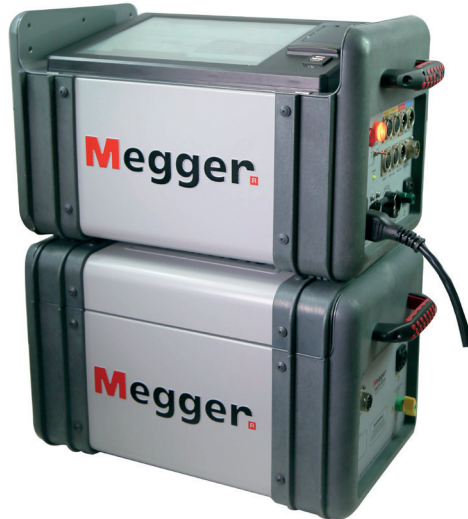
### DELTA:

- Dedicated capacitance and PF/DF test instrument (also exciting current)
- Narrowband DFR (NB DFR: 1 - 500 Hz)
- Individual Temperature Correction (ITC)
- Voltage Dependence Detection (VDD)

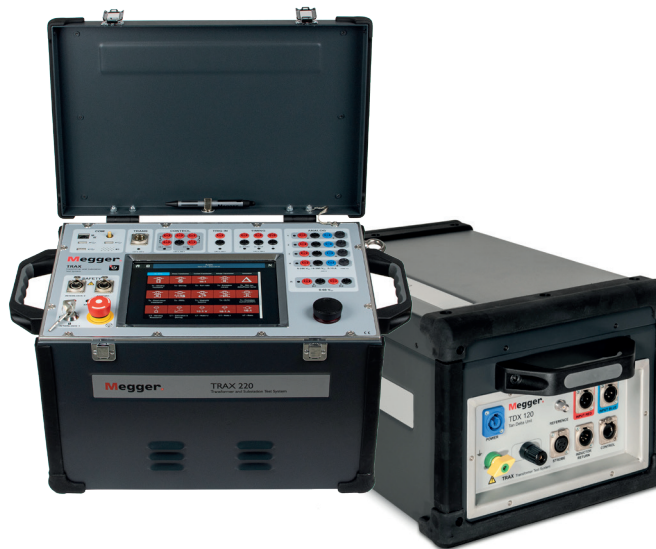
### TRAX + TDX

- A multi-functional tester for transformer and substation equipment
- Narrowband DFR (NB DFR: 1 - 500 Hz)
- Individual Temperature Correction (ITC)
- Voltage Dependence Detection (VDD)
